# REVIEW OF MEAKIN ESTATE

## HEATING AND HOT WATER SERVICES

**MEAKIN ESTATE  
DECIMA STREET  
LONDON SE1**

**Report Date: June 2019**

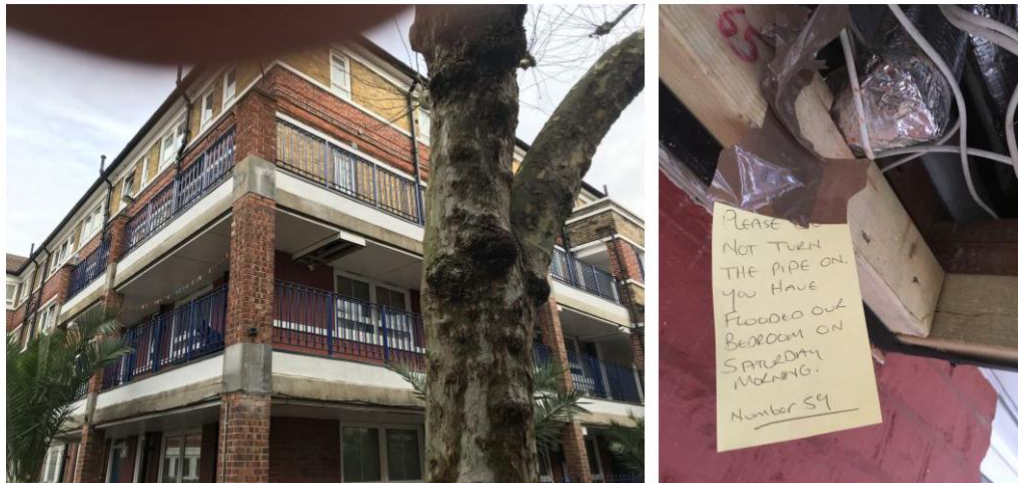
No. 65 Meakin

During our site visit we noted that a panel was missing on one of the blocks and on closer investigation found a note from No.59 requesting that the leaseholder in No.65 “do not turn on the valves again” because they have flooded them out over the weekend” See attached photo taken at the time of our visit.

This suggests that the leaseholder in No. 65 has been carrying out some works within the dwelling to the heating system which may have caused the pressure loss on the system.

The loss of pressure to the system is deemed to have been possibly caused by works carried out by the leaseholder in flat No. 65 and this is being investigated by the JMB directly.
